GE CF6-50 STAGE 1 FAN BLADE

Engine Manual 72-21-01

9211M73P02 to P08

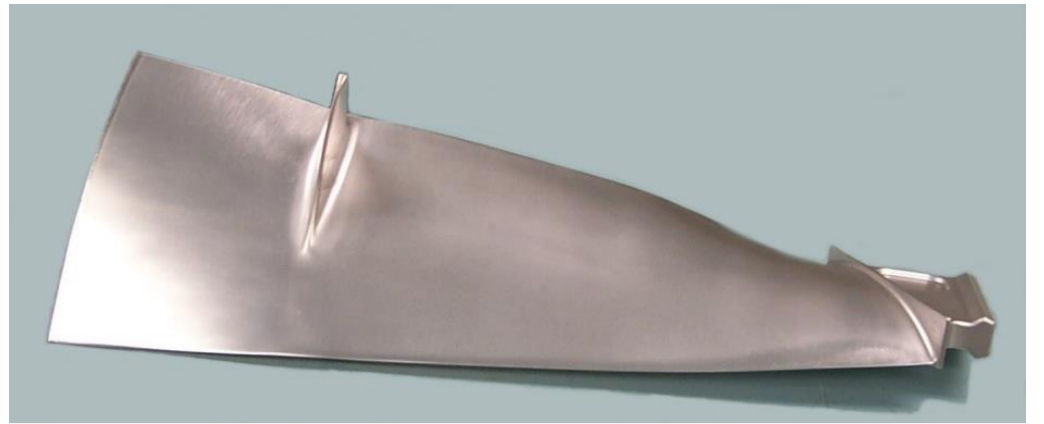
Solid Titanium Design, Midspan Shrouds, 38 Blades per Engine
Aircraft Type : DC10-10/15/30, A300B2/B4, B747-200/300
