CFM56-7B 1ST STAGE FAN DISK

Engine Service Manual 72-21-03

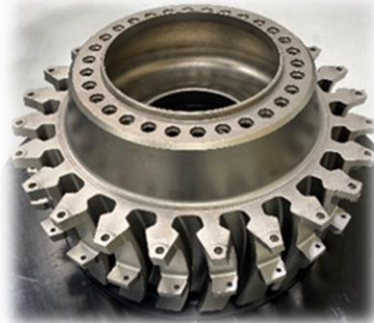
Solid Titanium Design,
 1 Fan Disk per Engine, 2 Engines per Aircraft
 Aircraft Type : BOEING 737-600, -700, -800, -900
