CFM56-2 1st STAGE FAN BLADE

Engine Manual 72-21-01

301-291-938-0 through 301-291-948-0, Pair Set No. 305-433-401-0

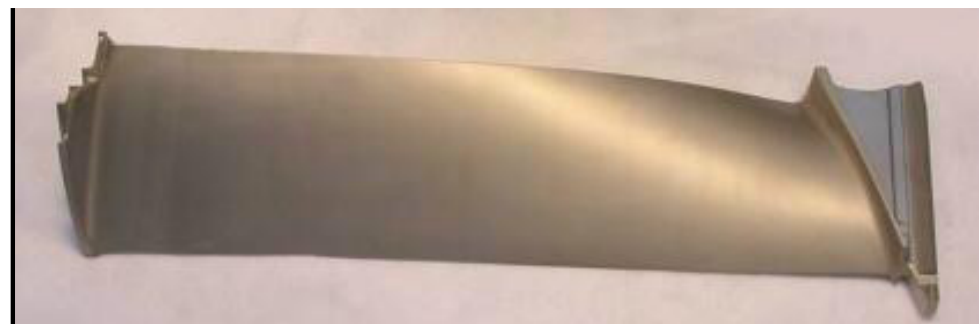
Solid Titanium Design with Tip Shroud, 44 Blades per Engine
Aircraft Type : DC8 - Super 70, KC135, C135, E3, KE3, E6, E8
