PW4000 Series - 94" 1st FAN BLADE

Engine Manual Section 72-31-82

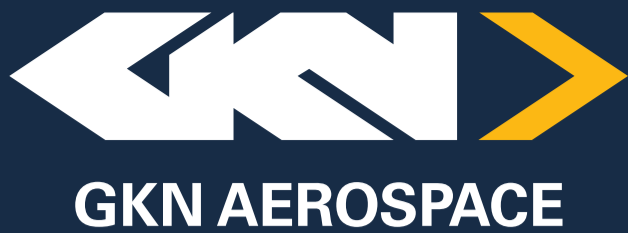
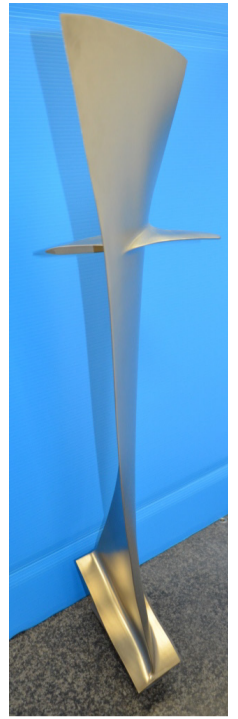
Solid Titanium Design, Midspan Shrouds, 38 Blades per Engine, PW4000-94" Stage 1 LPC Blade Assembly.
